Manhole Inspection Summary

Manhole # S09CC1013MH

Location Address: **3813 CALLAWAY AVE**

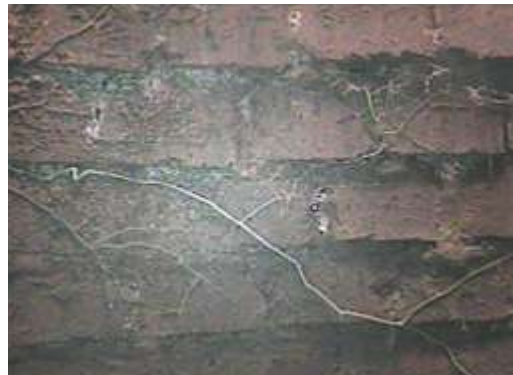
Defect 1

Condition: ☐ Sound ☐ Cracked ☒ **Root Intrusion** ☐ Loose Brick ☐ Deteriorated

Infiltration: ☐ None ☐ Joint ☐ Cracks ☐ Mortar ☒ **Roots** ☐ Wall

ROOT INTRUSION ON WALL

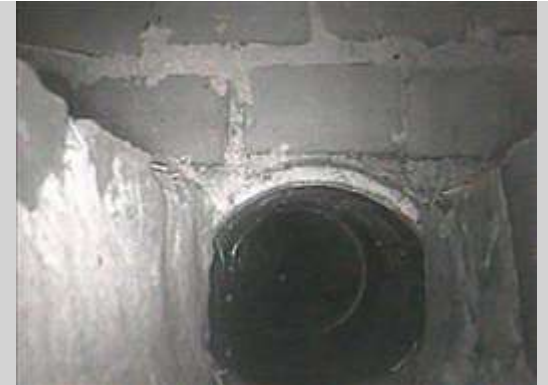
12 O'Clock Outflow

6 in. Circular Gravity Sewer
Pipe Out @ 12 O'Clock

Pipe Material: **Clay** ☐ Pipe Lined

Invert Depth: **6.87** (ft.) Flow Characteristics: **Slow**

Infiltration: **None** Pipe Seal Cond: **Sound**

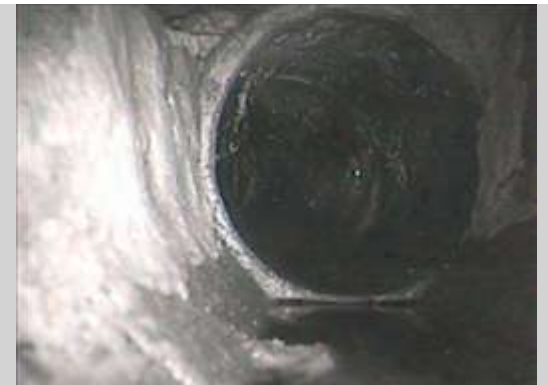
4 O'Clock Inflow

6 in. Circular Gravity Sewer
Pipe In @ 4 O'Clock

Pipe Material: **Clay** ☐ Pipe Lined

Invert Depth: **6.52** (ft.) Flow Characteristics: **None**

Infiltration: **None** Pipe Seal Cond: **Sound**

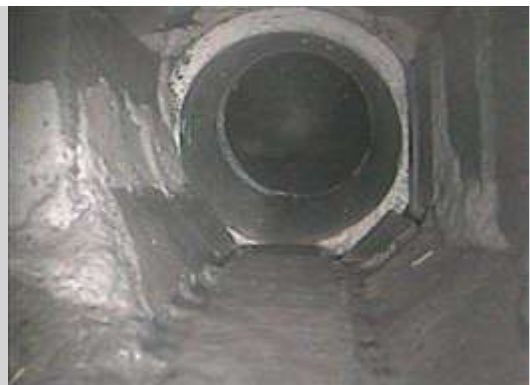
6 O'Clock Inflow

6 in. Circular Gravity Sewer

Pipe In @ 6 O'Clock

Pipe Material: **Clay** ☐ Pipe Lined

Invert Depth: **6.60** (ft.) Flow Characteristics: **Slow**

Infiltration: **None** Pipe Seal Cond: **Sound**
